SUPERFICIAL DEFECTS ON AISI 1118 STEEL PLATES

A.T.DUMITRESCU, A.CATANGIU

University Valahia Targoviste

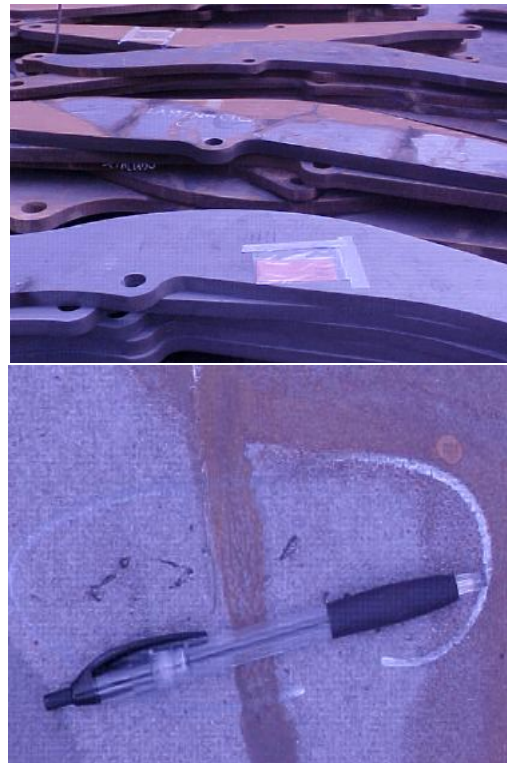
The observed defects are presented in Fig.1 and consist in discontinuous cracks developed in small plate area (50x170 mm).

Figure 1. Discontinuous cracks in different parts machined from a AISI 1118 plate

- The defect consists in a network of discontinuous cracks on the plate upper face in a small plate area (2"x7") (50x170 mm). This cracks configuration suggests intergranular cracks propagation.

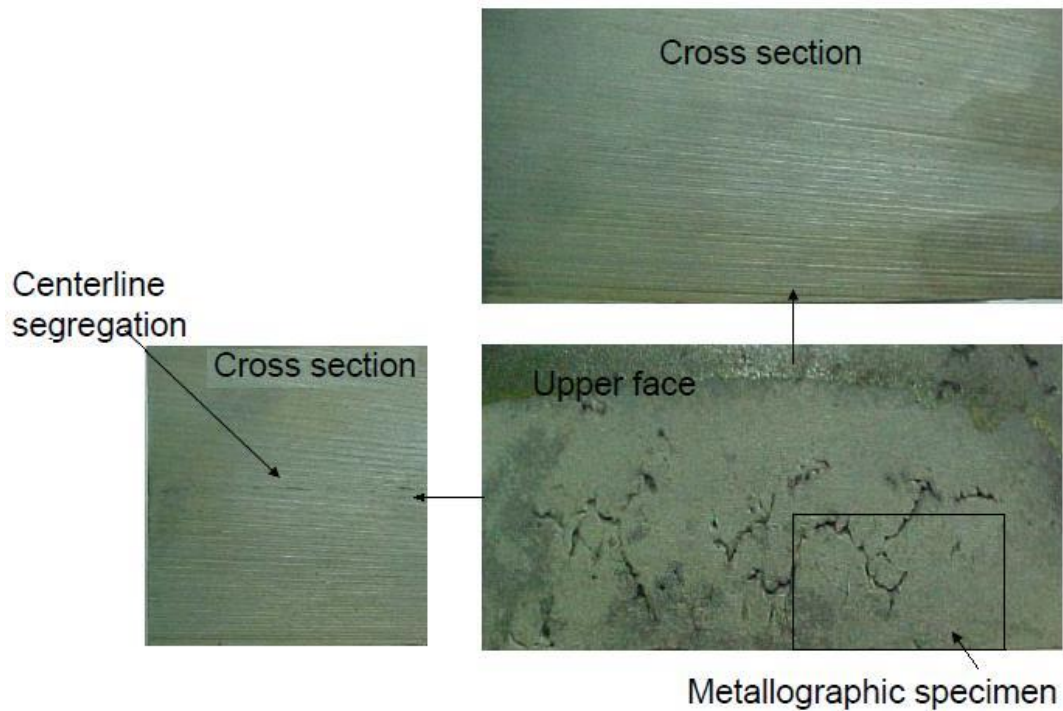
From the received sample a large zone has been removed by sawing, to avoid microstructure changes due to previous torch cutting. The new sample obtained has been etched for macroscopic analysis. Results obtained after sample macro-etching are presented in Fig.2, which

shows clear centerline segregation for one sample cross section and a network of discontinuous cracks on the plate upper face. This cracks configuration suggests intergranular cracks propagation.

The centerline segregation is a result of the high casting temperature, 1541°C, for a liquidus range of 1508°-1510°C.

Figure 2. Macro-etching

- The pronounced centerline segregation is a consequence of high temperature in tundish(1541°C) and consequently low casting speed even, the liquidus temperature is 1508°-1510°C.

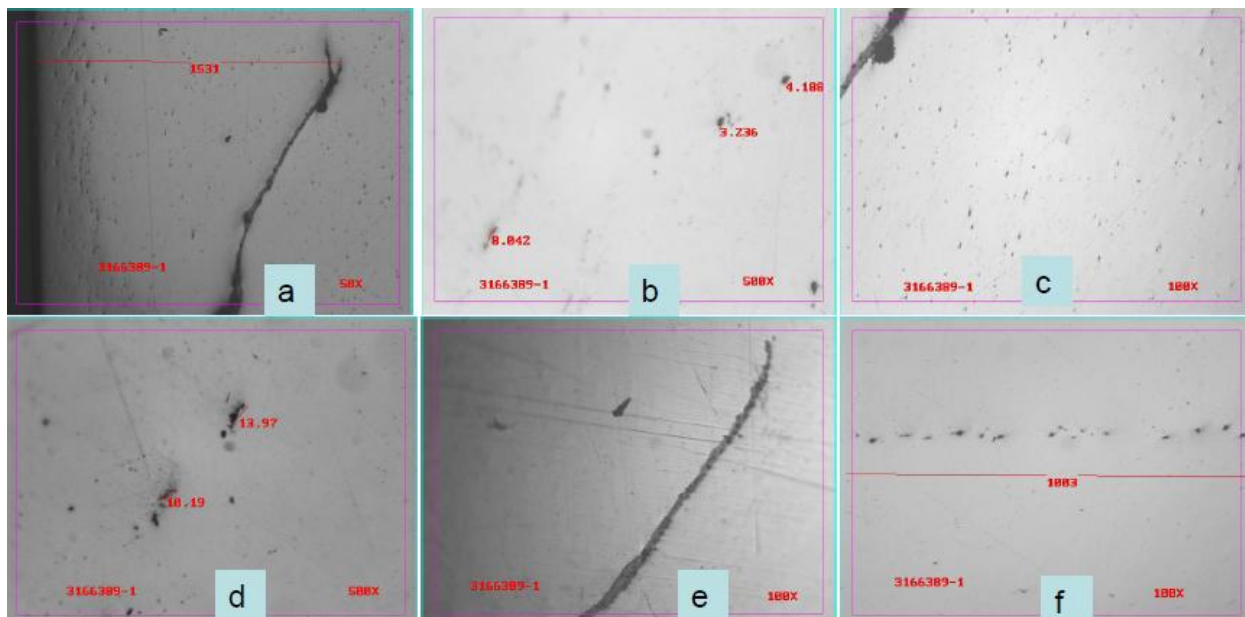
Figure 3 Metallographic analysis of un-etched specimens. 2%Nital Etching

On the sample cross section (longitudinal view) could be seen the cracks which penetrate into the plate until a depth of 1,5mm, Fig.3a.

Near the crack, but also in another specimen areas there are many D-type non-metallic inclusions, with the dimensions less than 8 μ m (Fig. 3a-c). The maximum dimensions of the inclusions in this specimen were 18 μ m

(Fig.3d) but also, was found an inclusion row with the length of 1000 μ m (Fig.3e).

- Near the crack, but also in other specimen areas there are many D-type non-metallic inclusions, with the dimensions less than 8µm. The maximum dimensions of the inclusions in this specimen were 18µm but also, was found an inclusion row with the length of 1000µm.

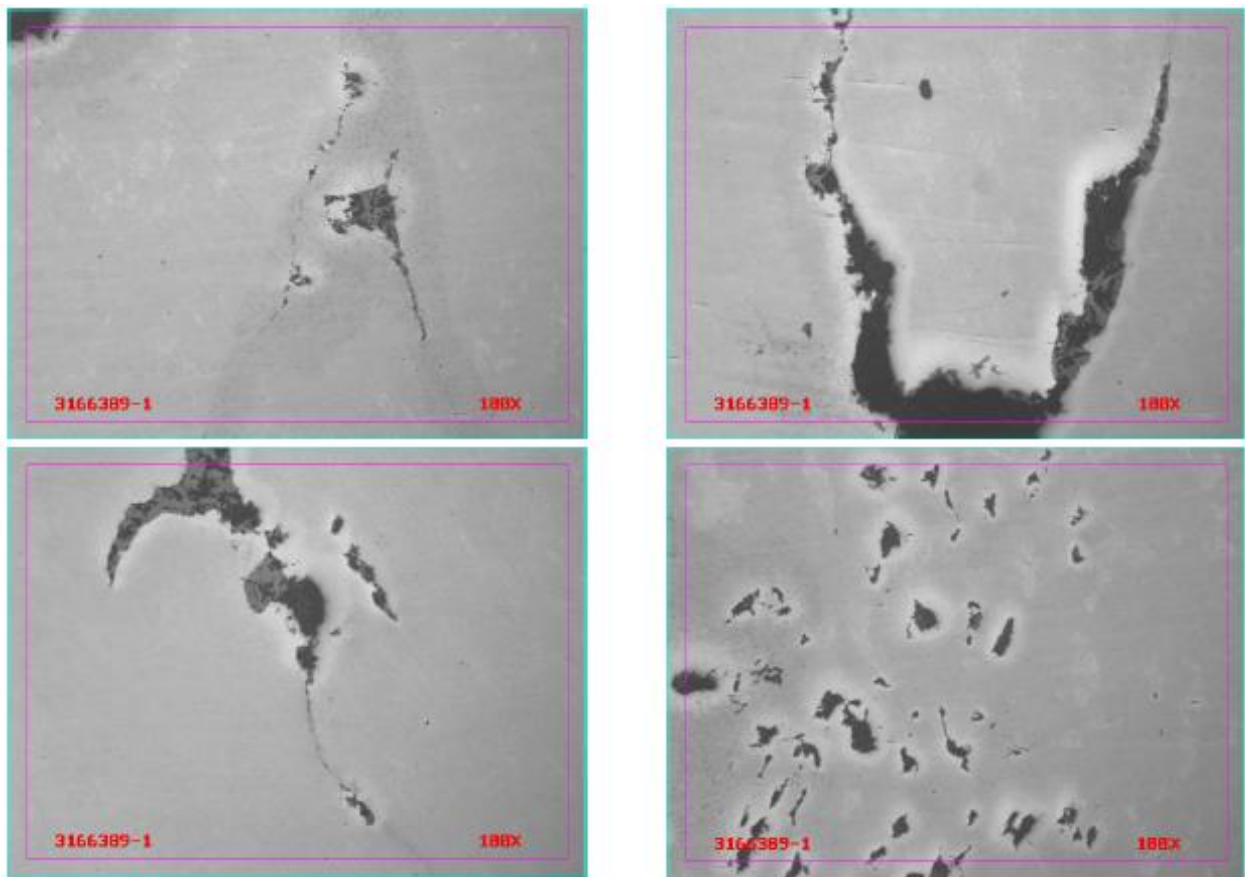
The analysis of the specimen upper face reveals not only a crack but, a network of cracks which connect oxide filled holes (Fig.4); these holes represent the tips of larger cracks.

Figure 4. Cracks filled with oxides

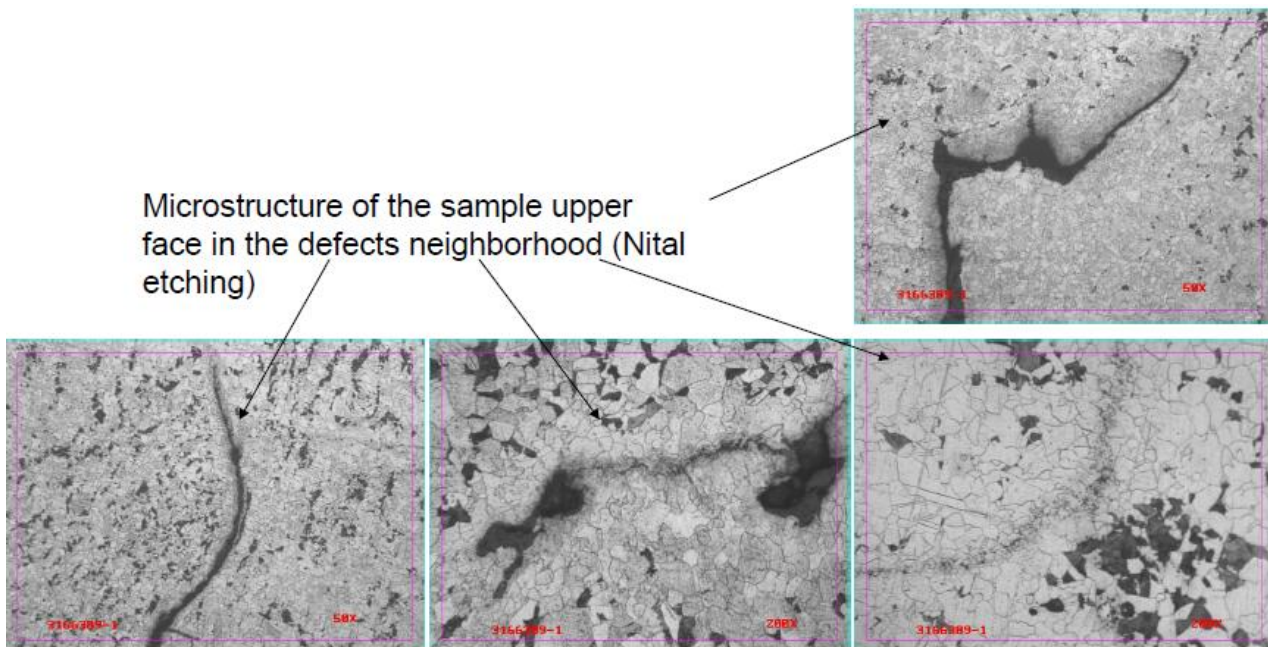
The chemical analysis of sample upper face reveals a carbon content of 0.16% in comparison with the carbon content of bulk, 0.21%, which means a high decarburization of the surface.

–The sample surface is highly decarburized, Fig.5.

Figure 5. Metallographic analysis of etched specimen.

- The chemical analysis of sample upper face reveals a carbon content of 0.16% in comparison with the carbon content of bulk, 0.21%, which means a high surface decarburization.

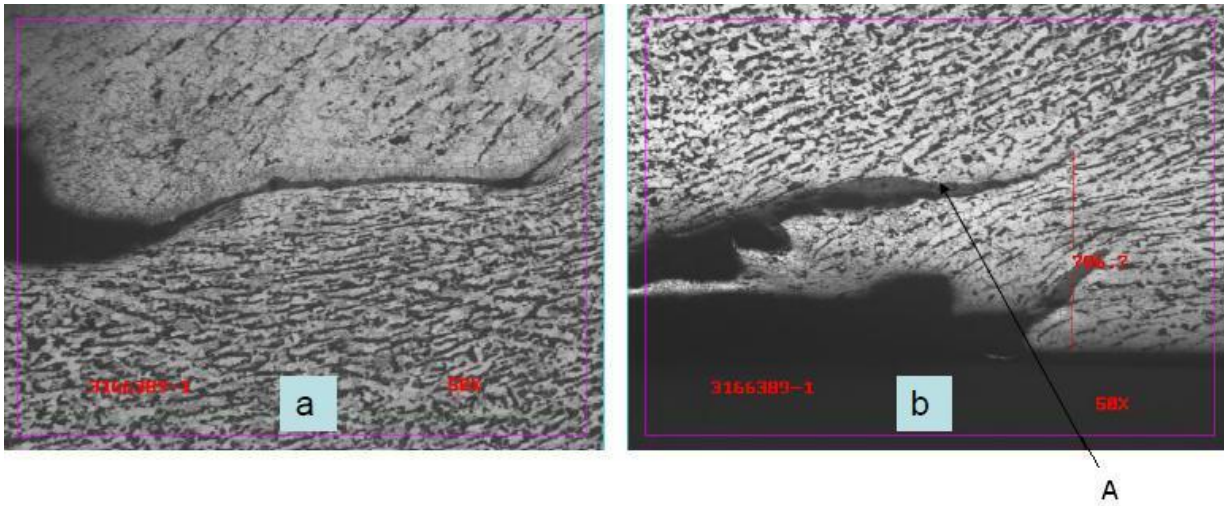
–The cracks are propagated in the decarburized layer until a depth of (780-1500) μ m, main part of the crack is filled by iron oxide and both sides of the crack which are decarburized, more or less, Fig.6.

Figure 6. Metallographic analysis of etched specimen. 2%Nital Etching

-the through cracks cross section specimen analysis, from Fig.6.reveals the presence of complex oxides on the crack tip, which chemical composition is shown in Fig.7. The SEM analysis of specimens:
 -the un-etched specimen surface from Fig.4 has been analyzed for determining the chemical composition of the oxides observed on this surface. The analysis showed the predominant presence of grey iron oxide

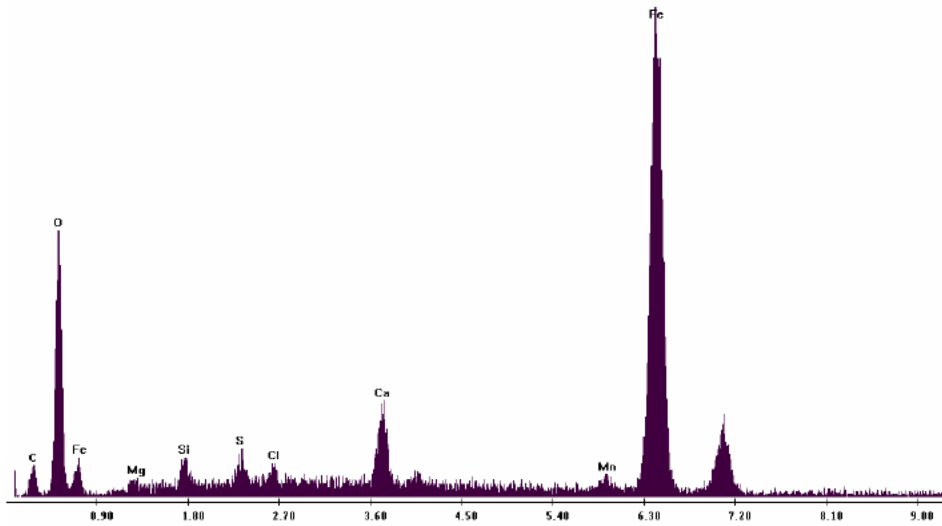
Figure. 7 Chemical composition of A area from fig.6

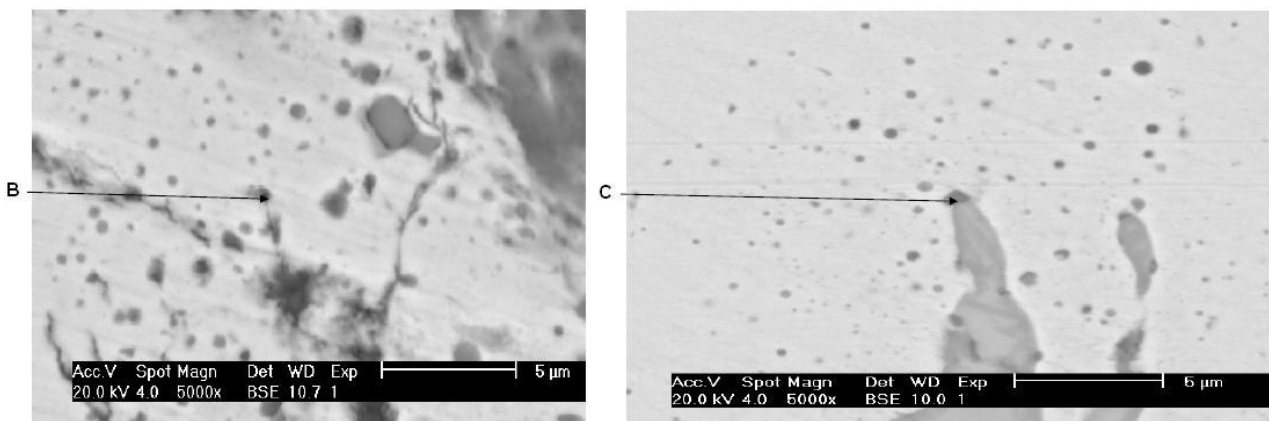
Figure 8 Position of areas from the unetched specimen surface analyzed by EDAX (oxides and slag inclusion)

and besides it, dark grey areas of slag with different chemical composition, Fig. 8,9,10. The high aluminum ratio (Fig.10) from B area in Fig.9 is the result of aluminium oxide clusters analysis. Usually alumina clusters are inclusion which occur below the slab top surface only, mainly on low carbon, aluminum killed steels. The inclusions occur randomly anywhere through the length of the slab.

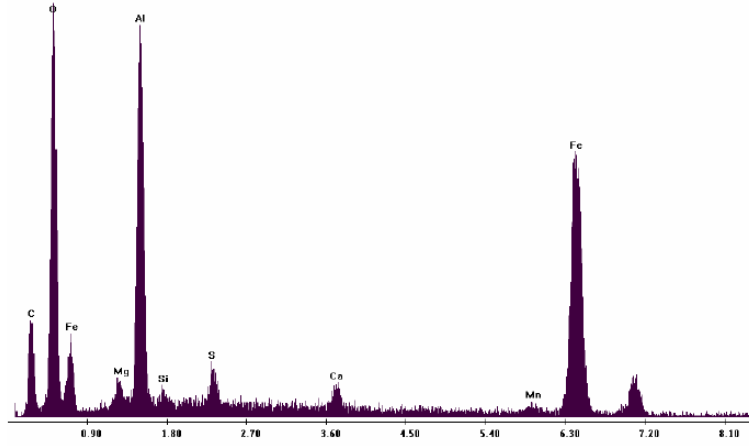
Figure. 9 Chemical composition of B area from fig.8

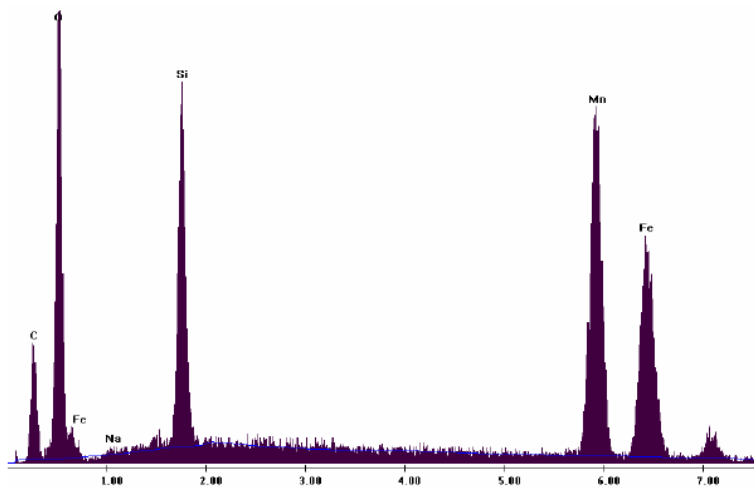
Figure. 10 Chemical composition of C area from fig.8

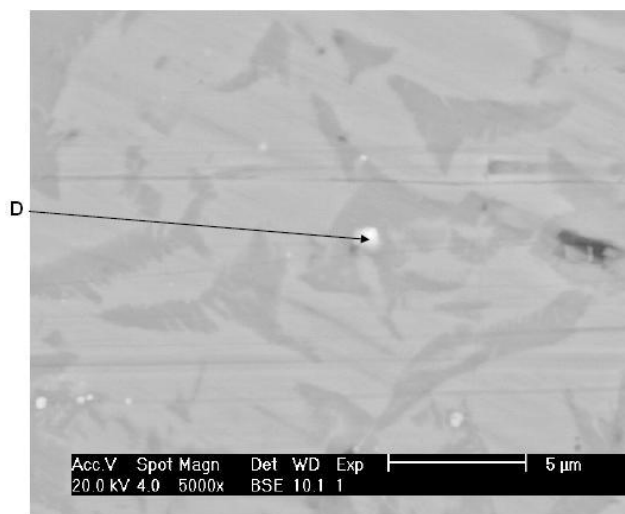
Figure 11. SEM analysis of crack area (inclusions)

In the same crack area could be observed small (500nm), spherical, white, inclusions which contain besides S,O,Fe, small quantities of Cu and Ni, Fig.11,12.

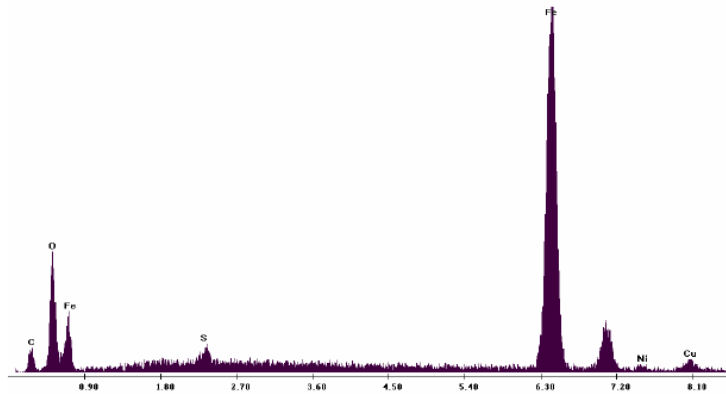
Figure. 12 Chemical composition of D area from fig.11

The chemical composition of this area are revealed in EDAX analysis from Fig.12
