SLIVER DEFECTS ON LOW CARBON STEELS, COLD ROLLED STRIPS

Dumitrescu A.T., Catangiu A.

University Valahia of Târgoviște

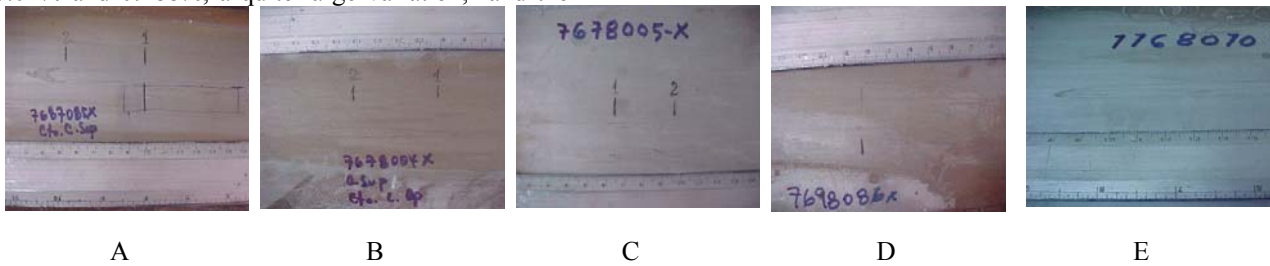
Figure 1. Metallographic specimens cut out from tested coils

In Fig.1A-D are presented the defects on the surfaces of coils and the position for metallographic specimens cutting. So, for example for A coil, the specimens 1 and 2 have been cut transversal and 3 longitudinal with respect to the rolling direction.

The position of defects, with respect to the strip width, is different from one strip to another, consequently seems not to be related to rolls or another equipment damage, even the defects appearance is quite similar, width of 8-15mm and length from 70 to 100mm.

In Fig.1B is presented the defect on the surface of B coil and the position for metallographic specimens cutting. So, the specimens 1 and 2 have been cut transversal to the rolling direction. Even the defect aspect looks like to

the defect from Fig.1A on the metallographic analysis didn't been observed oxydized zones inside the strip but only surface irregularities. Consequently, we believe the defect has been removed by pickling.

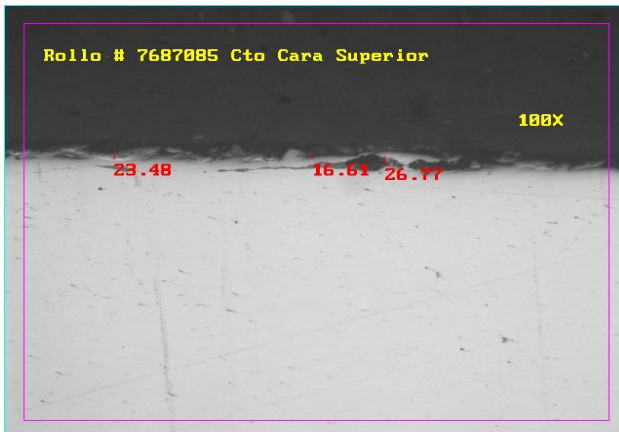
Figure 2. Metallographic examination of un-etched specimens (A coil)

After un-etched metallographic examination of specimens cut longitudinally with respect to the rolling direction it can be observed for A coil (Fig. 2), the defect consists on sub-surface iron oxides which have variable thickness (max. 26 μ m) and are found along the surface at the depth varying in the interval: 16-23 μ m.

The same defect has been observed for specimen no.2, the maximum depth being 26 μ m.

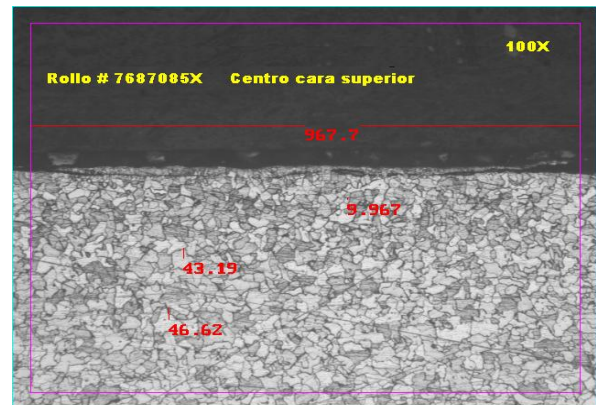
Figure 3. Metallographic examination of etched specimens (A coil; x100)

In Fig.3 the etched image of specimen no.1 shows that the defect belongs to a region without decarburization and the average grain size increases from the surface, where is 9, to 5-6 at 400 μ m depth.

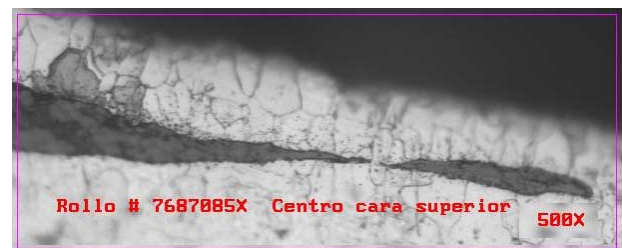
Figure 4. Metallographic examination of etched specimens (A coil; x500)

In Fig.4 is shown the defect zone at x500 magnification and can be seen the decarburization in the zone of defect.

In order to verify if the decarburization is related to the defect or not has been analyzed at the same magnification, another zone of the specimen, being observed the decarburized zone as in the Fig.4.

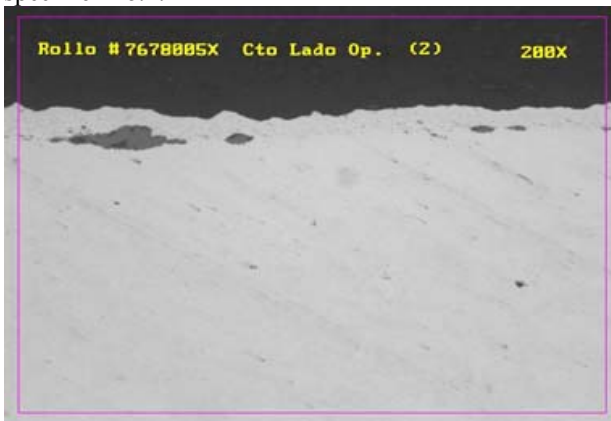
Figure 5. Metallographic examination of un-etched specimens (C coil)

The un-etched image of superficial defect shows iron oxides disposed under the strip surface at the depths which vary between 10µm and 20µm and defect thickness varies between 10 and 15µm.

The same results has been shown in Fig.5 for the specimen no.2, which is at 3cm distance from the specimen no.1.

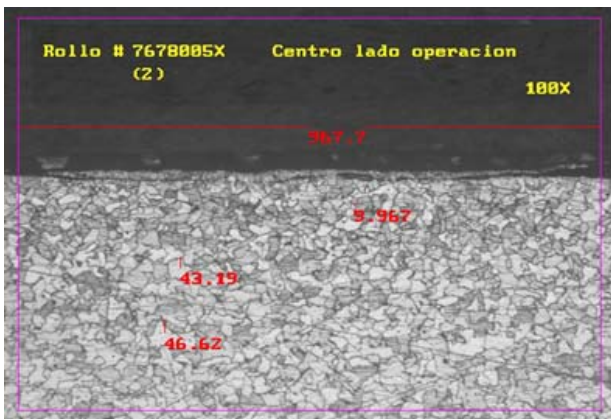
Figure 6. Metallographic examination of etched specimens (C coil; x100)

In Fig.6 is shown the specimen no.1 from C coil in etched condition. It can be observed that the defect is discontinuous and some regions of it are connected to the surface.

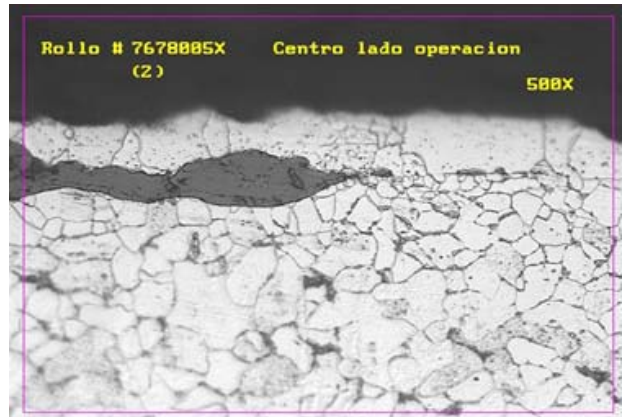
Figure 7. Metallographic examination of etched specimens (C coil; x500)

In Fig.7 the same defect area as in Fig.6 are presented at higher magnification.

In these figure (Fig.7) can be observed a light decarburization, but only along of a one grain size depth. In Fig.1D is shown the defect on the surface of D coil and the position for cutting of metallographic specimen. From Fig.8 can be observed that the defect is similar to the previous presented and consisting of rows of iron oxides along the strip surface and at a depth of 30-40µm.

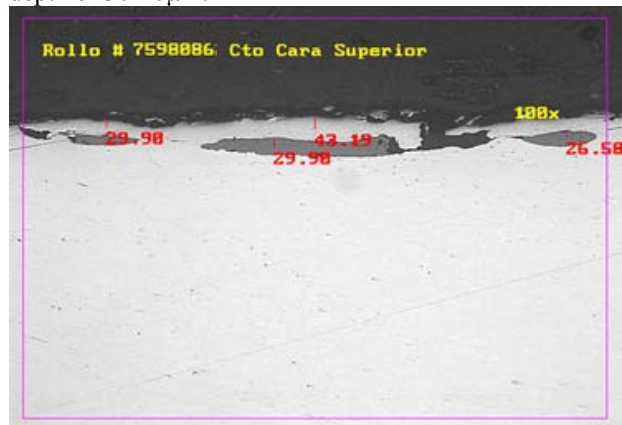
Figure 8. Metallographic examination of un-etched specimens (D coil)

The defect thickness varies between 20 and 36µm.

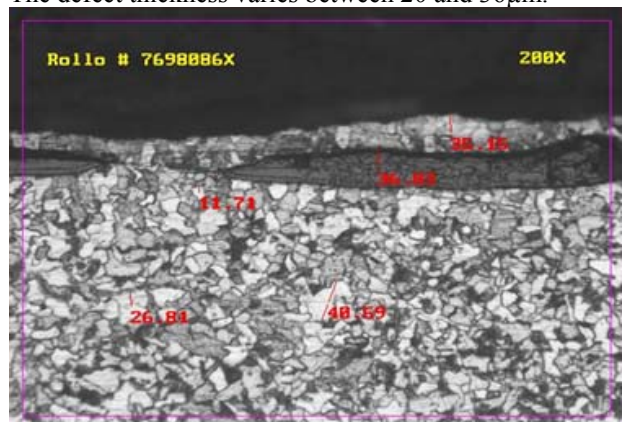
Figure 9. Metallographic examination of etched specimens (D coil; x100)

In Fig.9 is shown the etched image of the specimen and can be observed the grain size variation across

the thickness and the absence of decarburization along the iron oxides from the surface.

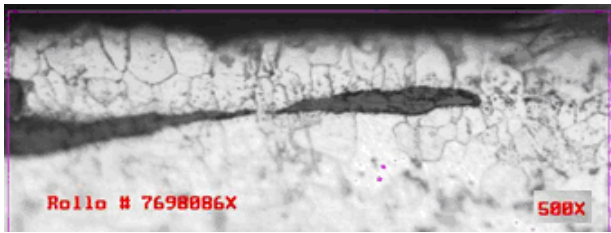
Figure 10. Metallographic examination of etched specimens (D coil; x500)

In Fig.10 is shown the defect zone at x500 magnification and can be observed the decarburized zone over the defect.

Metallographic examination at the same magnification performed over another zone of the specimen far away from the defect is shown a decarburized zone with the same depth as in Fig.10.

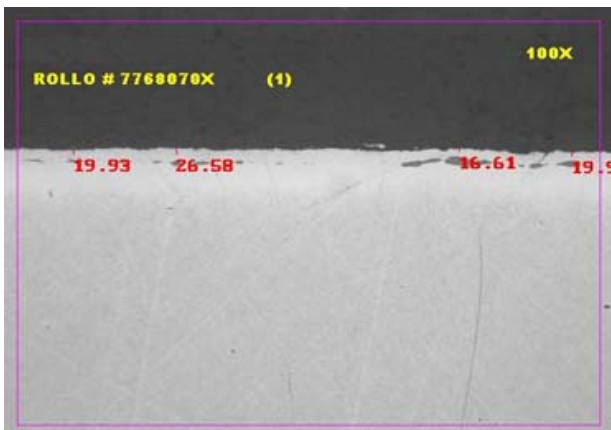
Figure 11. Metallographic examination of un-etched specimens (E coil)

In Fig. 11 is presented the un-etched image of the strip cross section in the defect zone and can be observed that under the strip surface there are rows of iron oxides which thickness varies between 10 to 17 μ m and they are at 16-27 μ m under the strip surface.

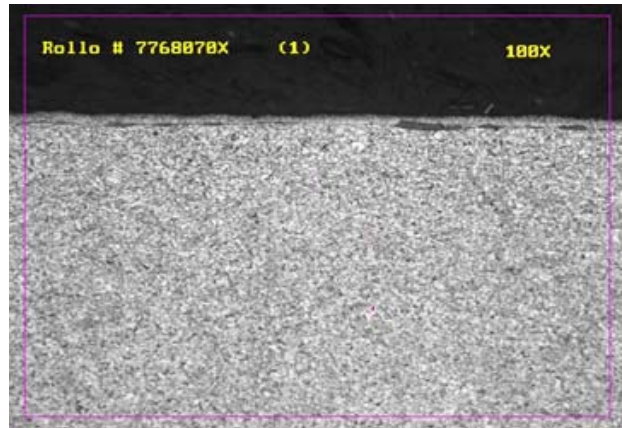
Figure 12. Metallographic examination of etched specimens (E coil; x100)

In Fig.12 is shown the etched image of the cross section through the strip in the defect zone and can be observed the fine granulation of this strip, 10-11.

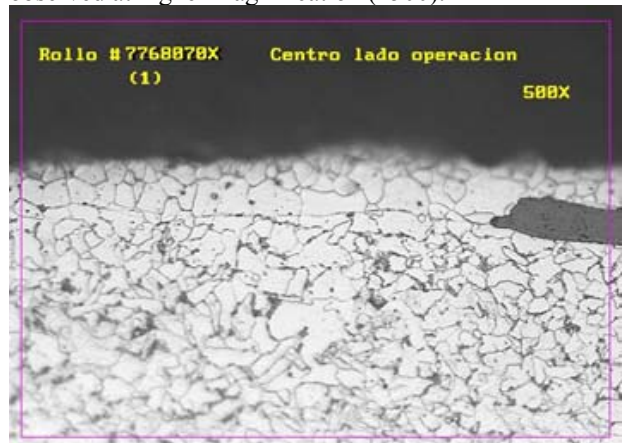
Figure 13. Metallographic examination of etched specimens (D coil; x500)

In Fig.13 the same zone as from the Fig.12 is observed at higher magnification (x500).

At this magnification can be observed that the iron oxides are connected to the surface by very fine cracks, which cross the grains, parallel to the specimen surface. Over this crack is observed a light decarburization.
